**FAC – Lower Water Street Roof Replacement
U&U**

UARB APPROVAL SHEET

ROOF CONDITION ASSESSMENT REPORT

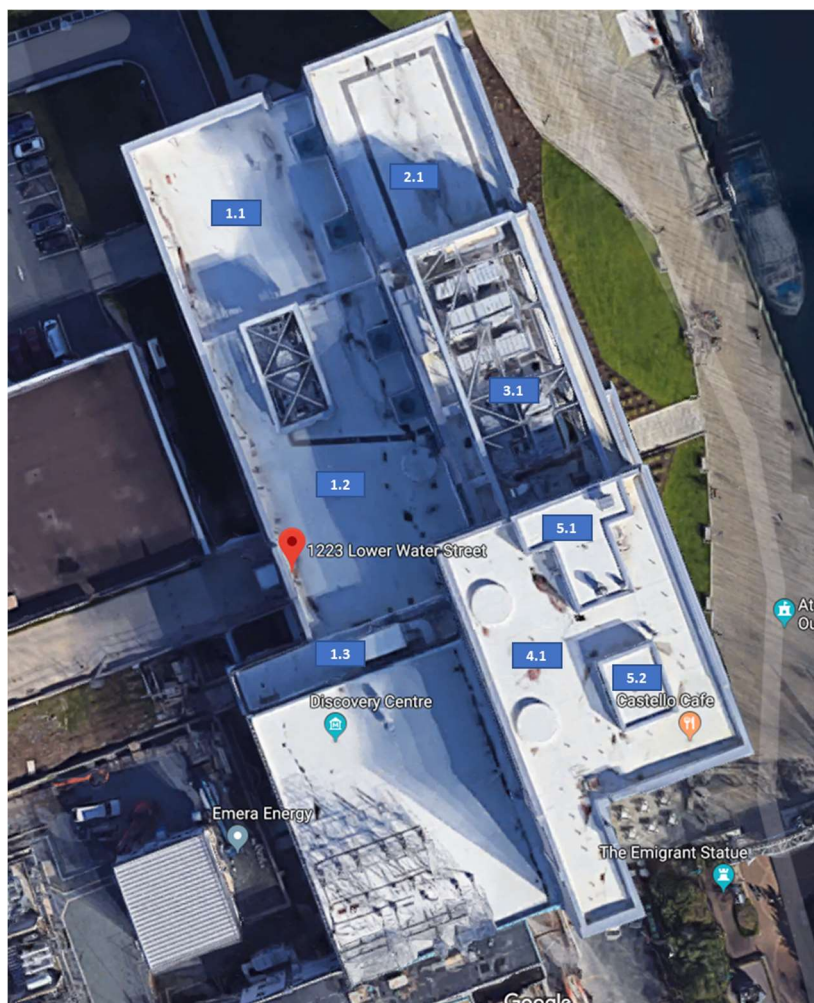
The scope of this project is the replacement of five roof sections at 1223 Lower Water Street due to severe delamination of the existing roof membrane. This project includes only those costs associated with the regulated portion of the Lower Water Street building (sections 1.1, 1.2, 1.3, 4.1 and 5.2 of the roof as illustrated in the diagram below).

Based on the recommendations in IRC's roof condition assessment report, replacement of five roof sections needs to be completed now to avoid further water damage to the building and additional roof delaminations. This project includes only those costs associated with the regulated portion of the Lower Water Street building (sections 1.1, 1.2, 1.3, 4.1 and 5.2 as shown in the diagram above)

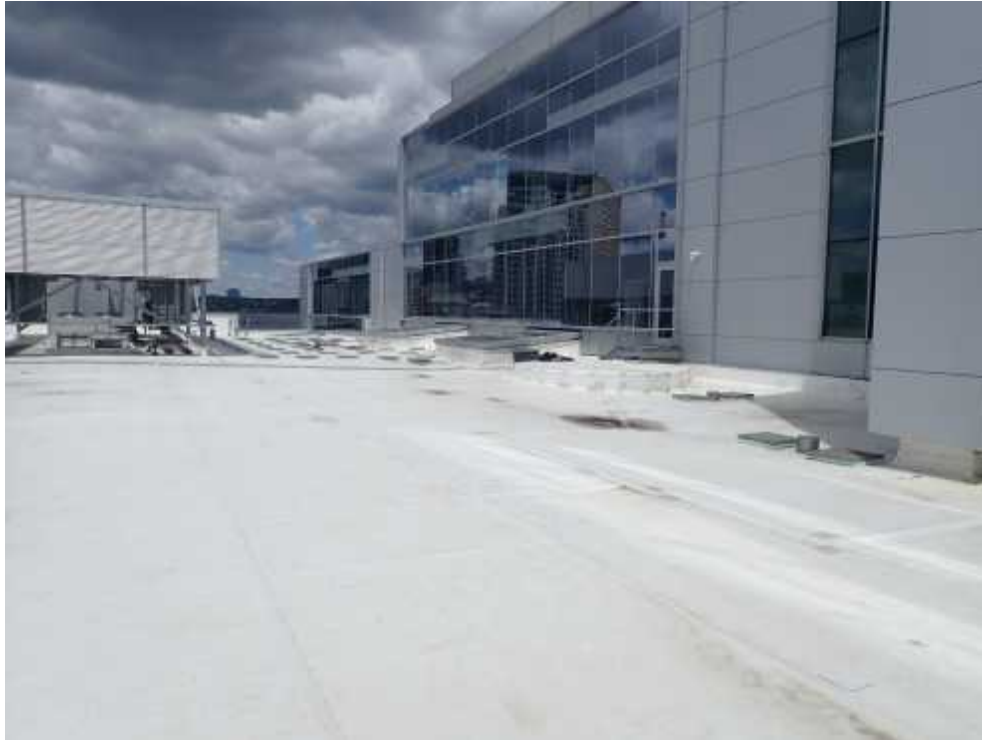
Photograph 18: Roof Area 1.2 – overall view looking north east. .

This roof area (Photograph 17 and 18) is located at the west half of the building and consists of a mechanically fastened TPO membrane system which is approximately 6 years old. The existing roof was completed in 2012 and consists of a concrete roof deck, peel & stick vapour barrier, 2 layers of 2." poly iso insulation, one layer of 0.5" recovery board (All adhered in place) with a fleece back Carlisle TPO single ply membrane also adhered to the existing recovery board using foamable adhesive.

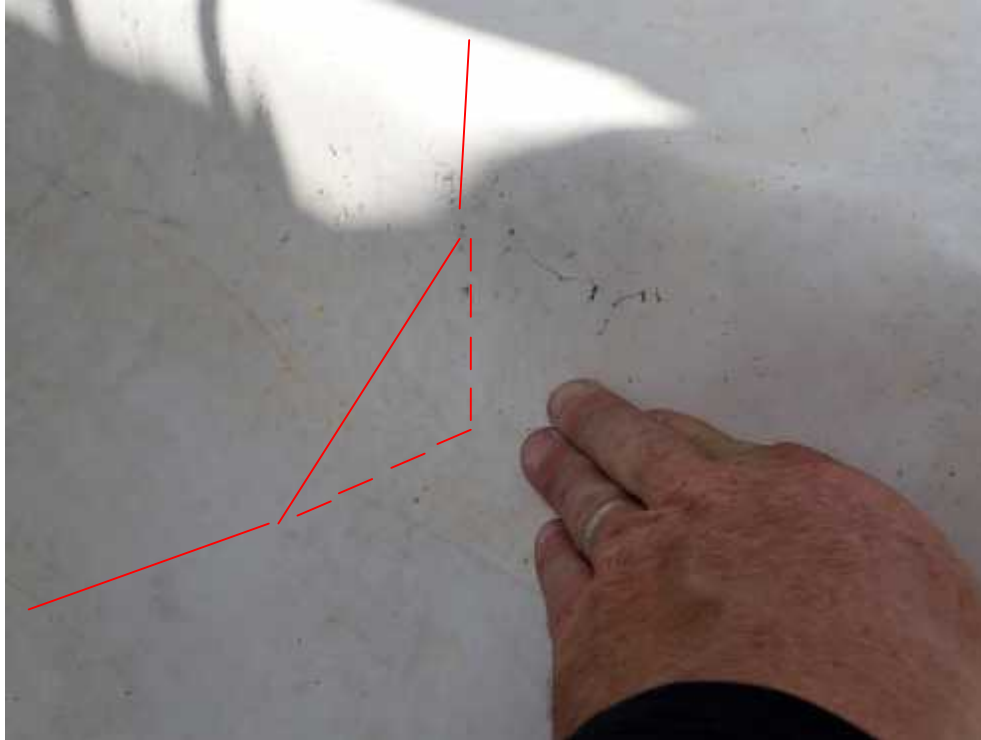
Photograph 24: Roof Area 1.2 – membrane tenting has occurred at the base of curbs. Solid lines show membrane tenting, dotted lines show where membrane would be located to be considered fully adhered.

6. Membrane tenting has occurred around the curbs in various areas. (Photograph 24).
7. A minor amount of standing water is evident due to debris build up around the roof drains.

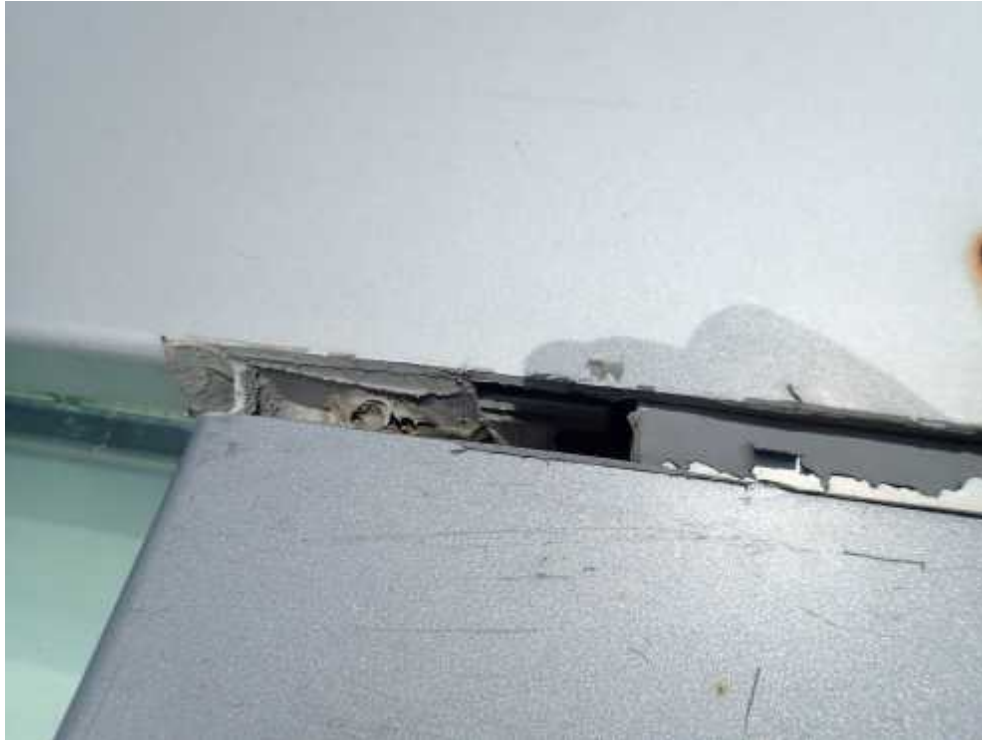
Photograph 28: Roof Area 1.2 – large voids in the sealant joint surrounding the skylight assembly.

10. One pipe box is also improperly sealed where the piping runs in to the curb. (Photograph 26).
11. The existing skylights are improperly secured to the curb allowing excessive movement to occur. Sealant separation is evident around the existing skylight frames in multiple areas. Multiple metal fasteners are missing around the flashing leaving them improperly secured. (Photograph 27 and 28).

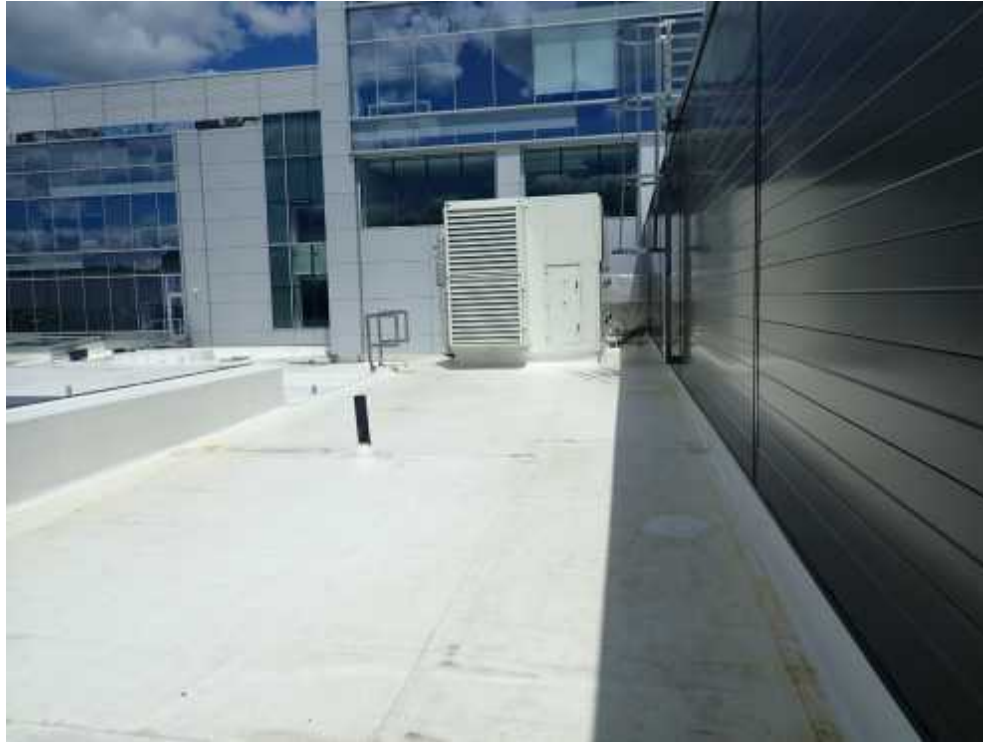
Photograph 31: Roof Area 1.3 – Overall view of roof area 1.3 facing east.

This roof area (Photograph 31 and 32) is located at the south west corner of the building and consists of a mechanically fastened TPO membrane system which is approximately 6 years old. The existing roof was completed in 2012 and consists of a concrete roof deck, peel & stick vapour barrier, 2 layers of 3." poly iso insulation, no recovery board (All adhered in place) with a fleece back Carlisle TPO single ply membrane also adhered to the existing recovery board using foamable adhesive.

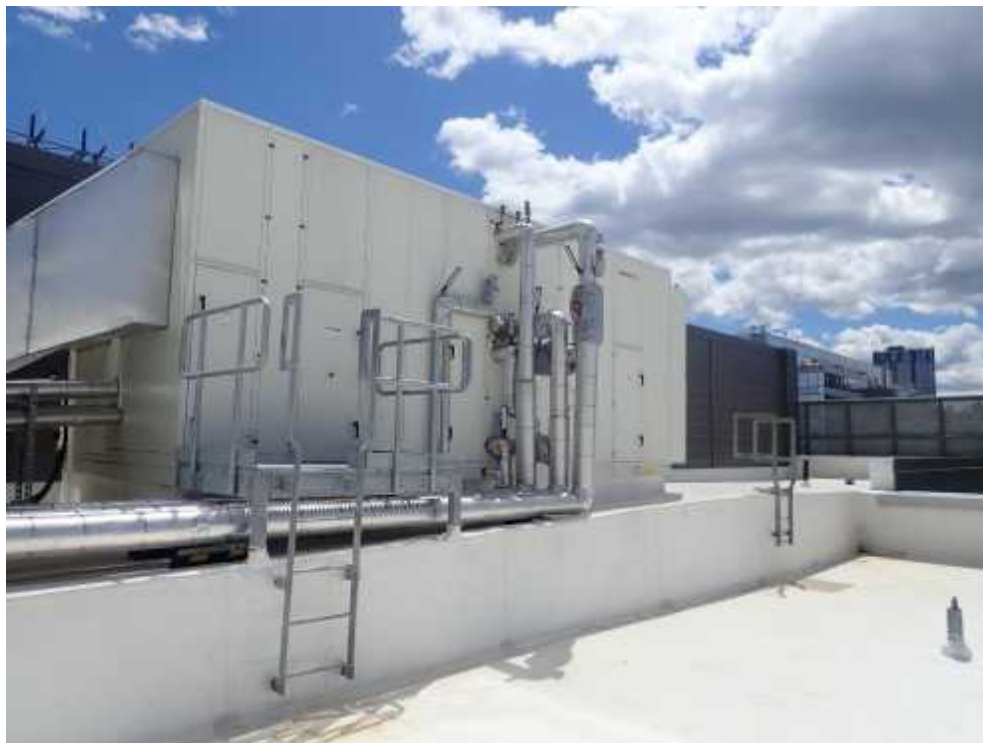
Photograph 32: Roof Area 1.3 – overall view of roof area 1.3 facing south west.

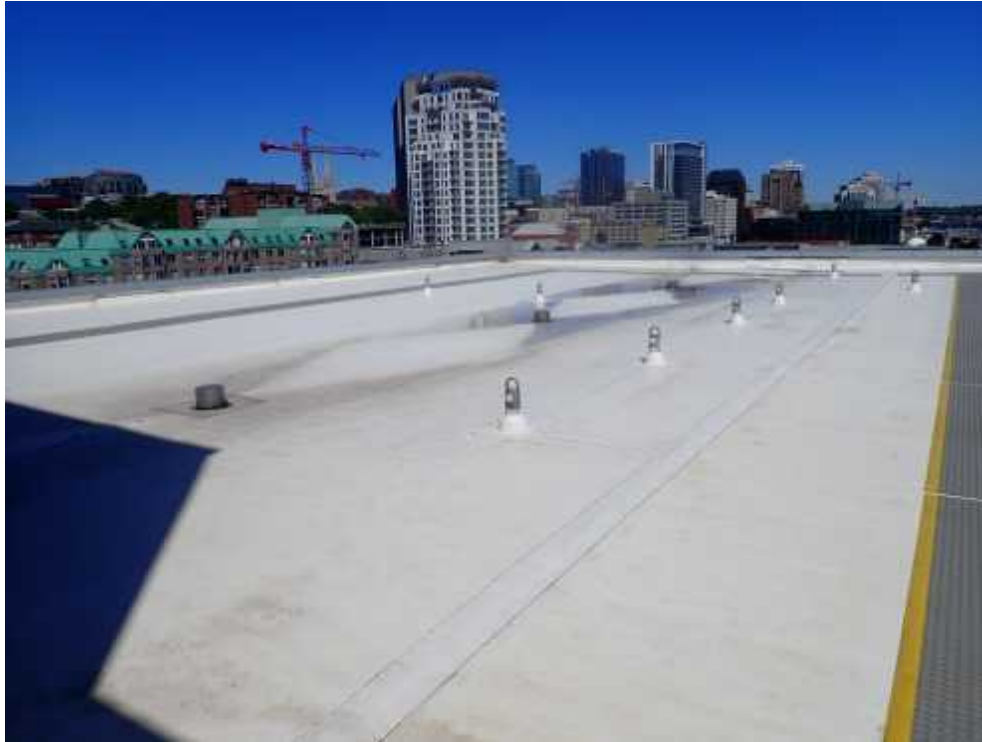
Photograph 37: Roof Area 2.1 – overall of the roof area looking north

This roof area (Photograph 37 and 38) is located at the north east corner of the building and consists of a mechanically fastened TPO membrane system which is approximately 6 years old. The existing roof was completed in 2012 and consists of a steel roof deck, peel & stick vapour barrier (over recovery board), 2 layers of 2." poly iso insulation, one layer of 0.25" recovery board (All adhered in place) with a fleece back Carlisle TPO single ply membrane also adhered to the existing recovery board using foamable adhesive.

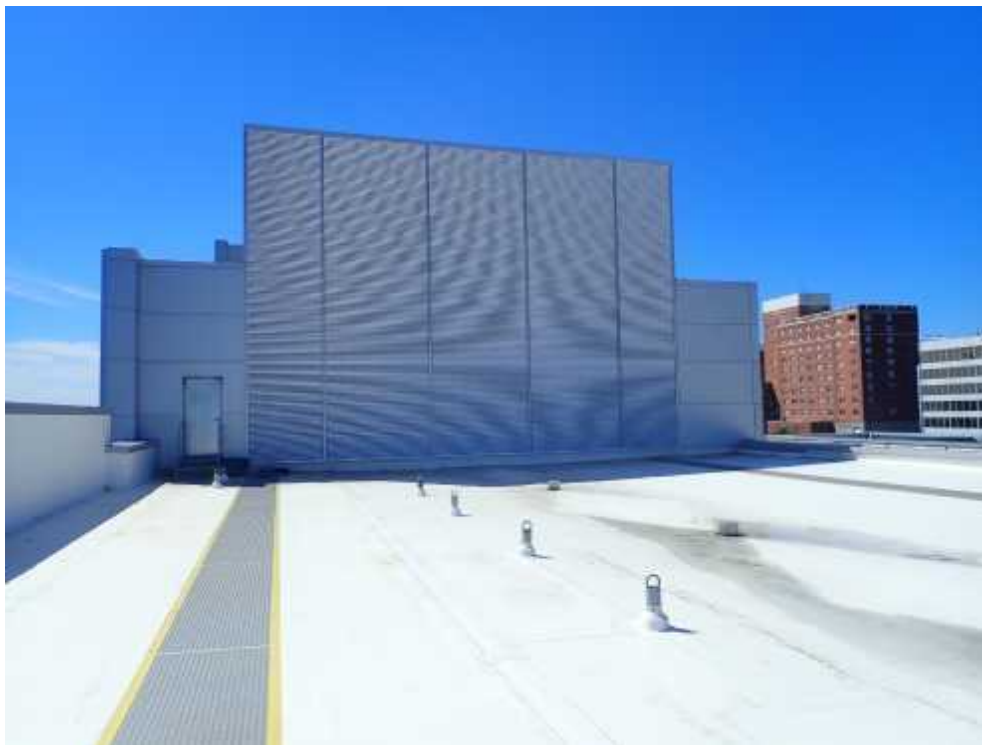
Photograph 38: Roof Area 2.1 – overall of the roof area looking south.

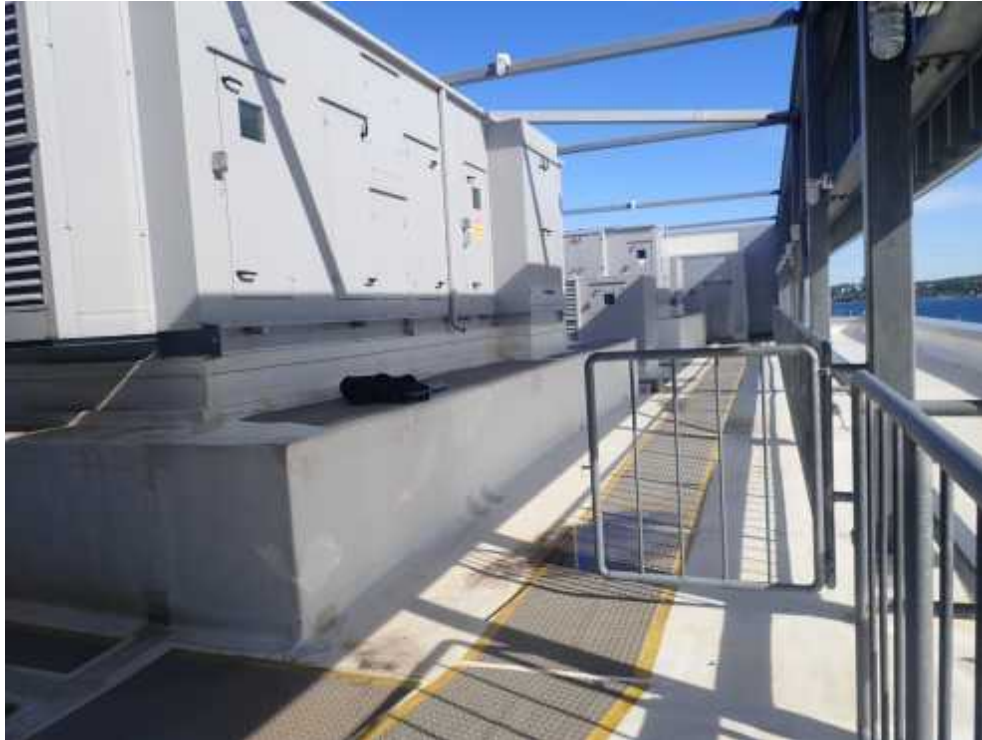
Photograph 44: Roof Area 3.1 – Partial view facing north

This roof area (Photograph 44 and 45) is located at the east half of the building and consists of a mechanically fastened TPO membrane system which is approximately 6 years old. The existing roof was completed in 2012 and consists of a concrete roof deck, peel & stick vapour barrier, 2 layers of 2" and 1 layer of 1" poly iso insulation, one layer of 0.25" recovery board (All adhered in place) with a fleece back Carlisle TPO single ply membrane also adhered to the existing recovery board using foamable adhesive.

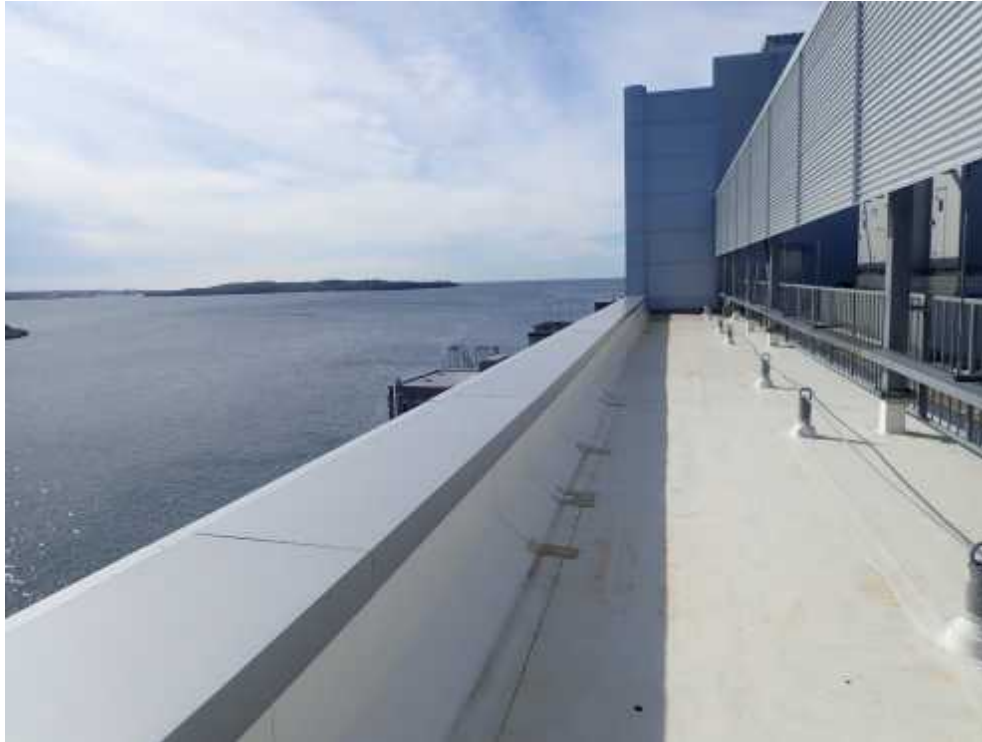
Photograph 45: Roof Area 3.1 – Partial view facing south.

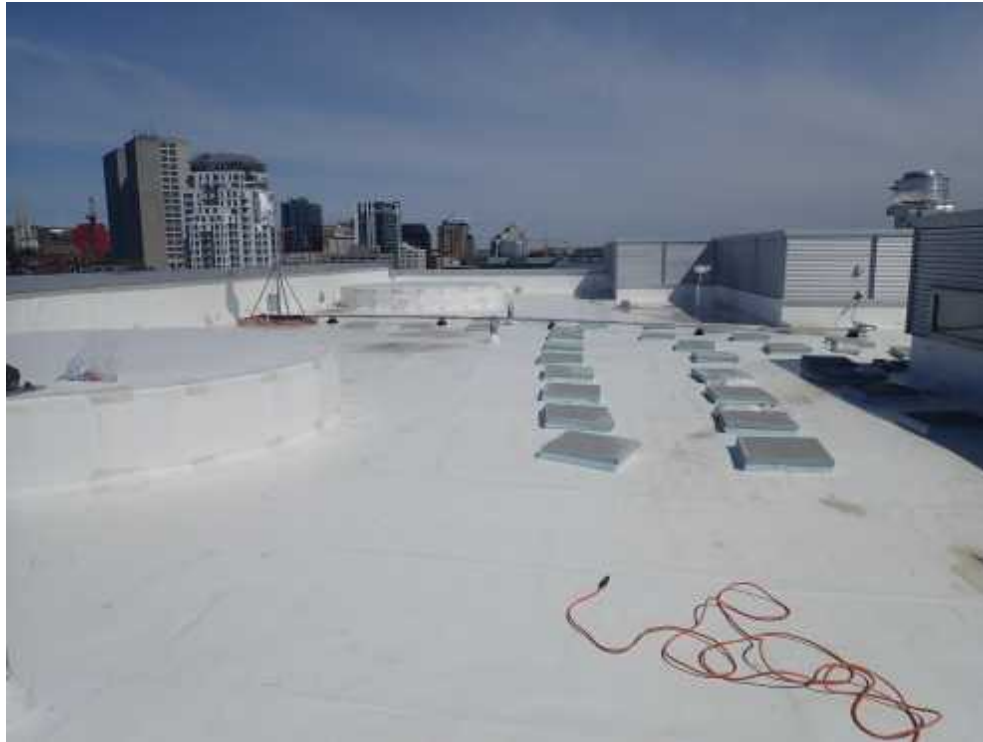
Photograph 53: Roof Area 4.1 – Partial roof view facing north along the west half of the roof.

This roof area (Photograph 53 and 54) is located at the south half of the building and consists of a mechanically fastened TPO membrane system which is approximately 6 years old. The existing roof was completed in 2012 and consists of a concrete roof deck, 4 ply built up roof, peel & stick vapour barrier, 2 layers of 2" poly iso insulation, one layer of 0.25" recovery board (All adhered in place) with a fleece back Carlisle TPO single ply membrane also adhered to the existing recovery board using foamable adhesive.

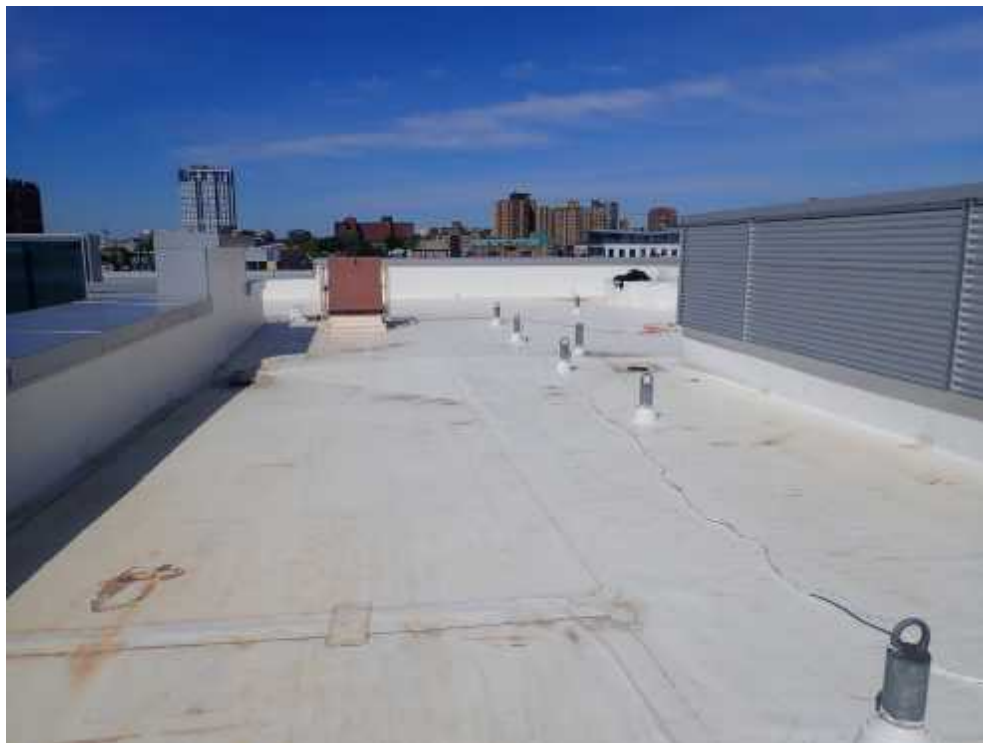
Photograph 54: Roof Area 4.1 – Partial view of the roof area facing west.

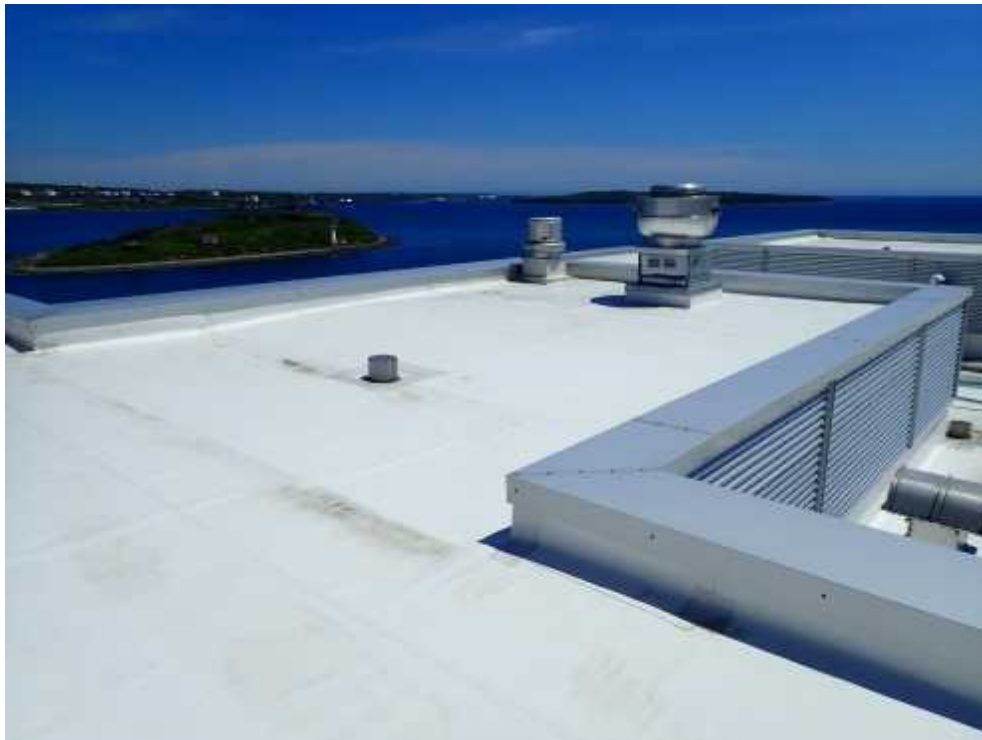
Photograph 64: Roof Area 5.1 – Overall view of the roof area facing south

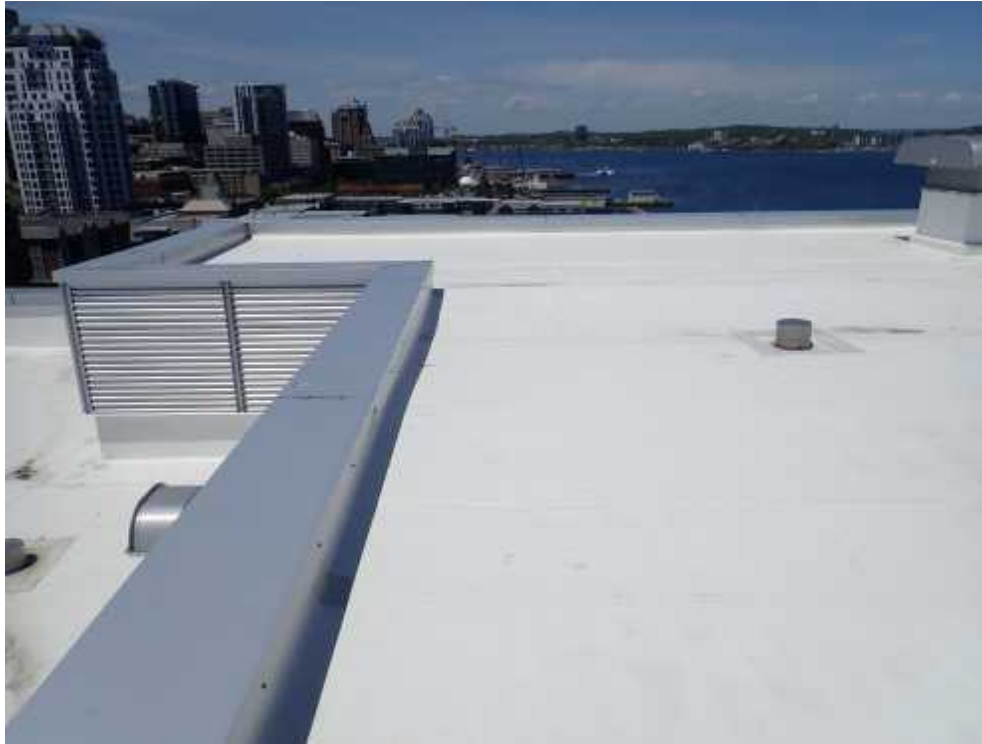
Photograph 65: Roof Area 5.1 – overall view of the roof area facing north. .

1. The existing membrane is in fair condition and is adhered to the underlayment board except where noted.
2. Multiple repairs have been completed in various areas and there are no reported leak areas.
3. Ridging is evident in multiple areas on the field of the roof. (Photograph 66).
4. Minor membrane tenting has occurred around the perimeter walls in various areas. (Photograph 67).
5. All membrane seams checked were sealed to acceptable standards.

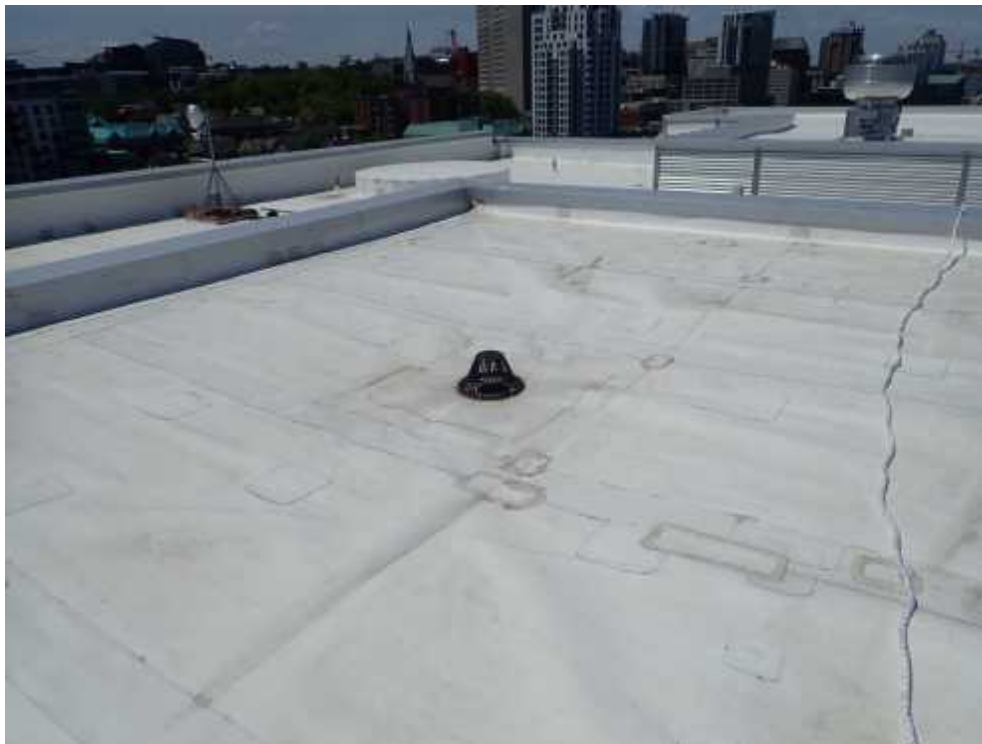
Photograph 68: Roof Area 5.2 – Overall view of the roof area looking north west.

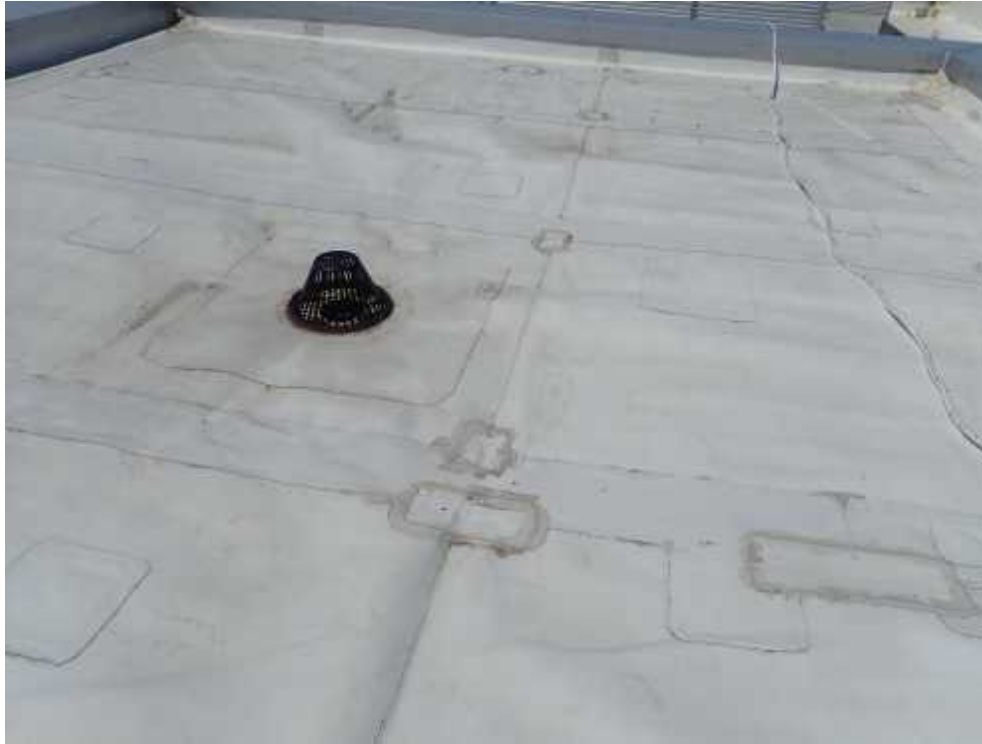
Photograph 69: Roof Area 5.2 – Overall view of the roof area looking south.

1. The existing membrane has suffered significant wind damage in a previous wind storm and is now fully separated from the recovery board on the entire roof area. (Photograph 70).

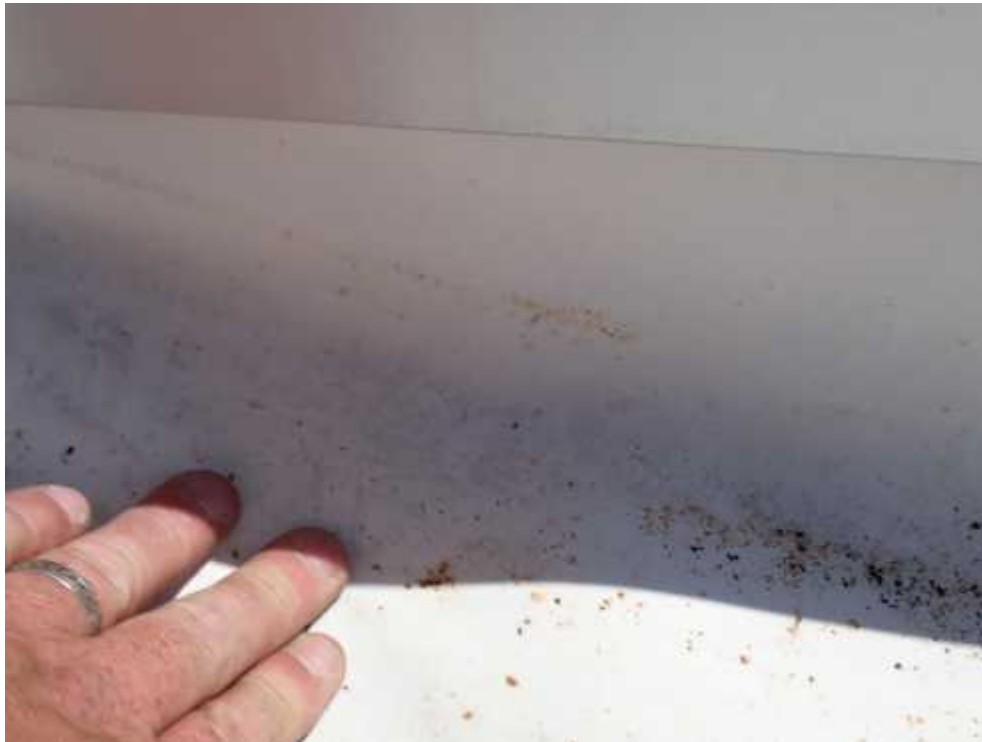
Photograph 71: Roof Area 5.2 – Membrane tenting at the perimeter of the roof.

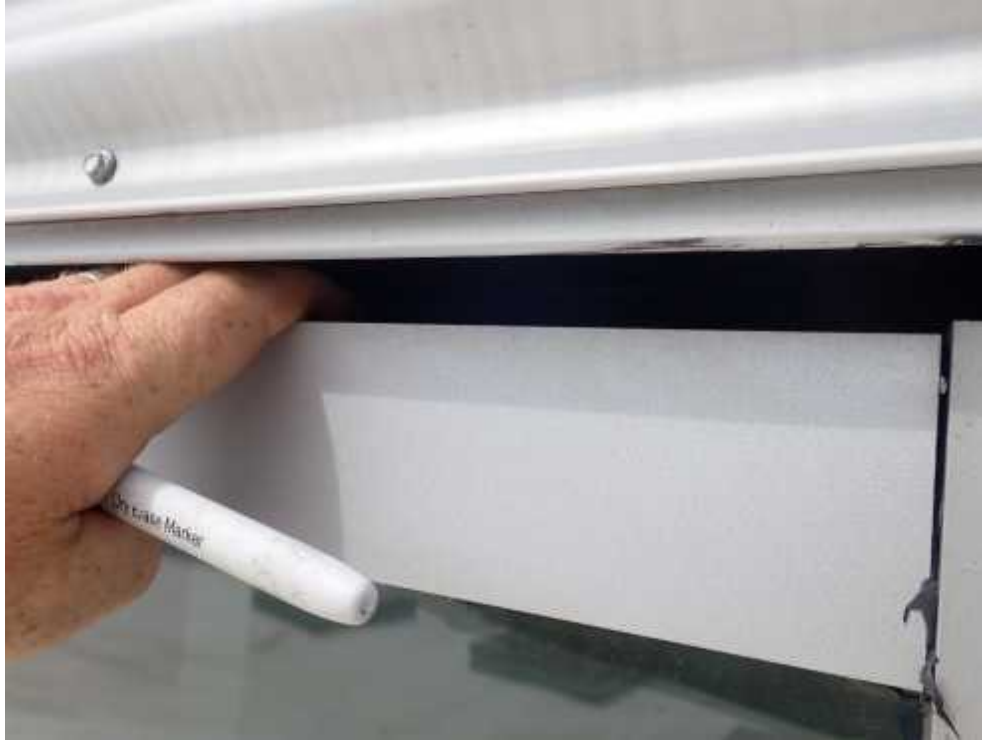
Photograph 73: Wall area below roof area 5.2 – large gaps at window head.
